ETHICON, INC.

SEVEN YEAR DATA FOR TEN YEAR PROLENE™ STUDY: ERF 85-219

Interim report on the physical testing of PROLENE, PVDF, ETHILON & NOVAFIL after seven year subcutaneous implantation in the Beagle Dogs - TEN YEAR BSR STUDY, STH211-92, 85-219

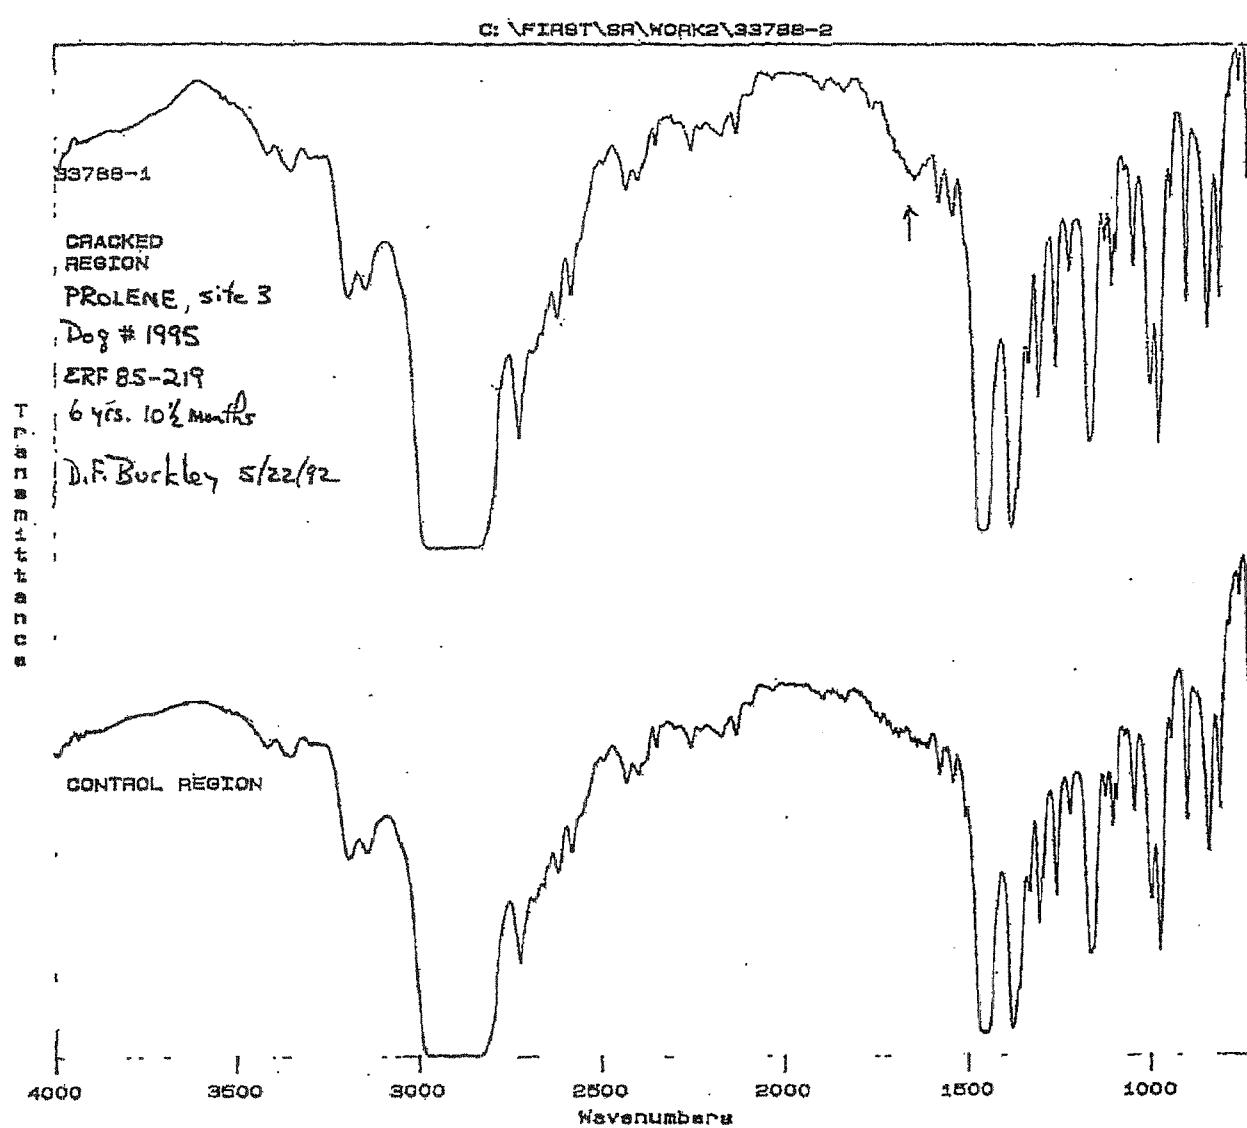
Figure A - Comparison IR Spectra of Cracked and Non-cracked Regions of PROLENE (SR33788)

IR microspectroscopy was used to examine cracked areas in ETHILON, Novafile and PROLENE™ explants. IR spectra obtained for cracked PROLENE specimens (Figure A) showed possible evidence of slight oxidation (a broadened weak absorbance at about 1650 cm⁻¹). IR spectra obtained for cracked areas of ETHILON and Novafile did not differ from uncracked areas (Figures B and C), but expected IR absorbances for oxidation would be masked by the strong carbonyl absorbances normally observed for these sutures. Figures D and E show pictures of the areas examined by IR microspectroscopy for ETHILON and Novafile.
